East Mountain

Level 2 Reserve Study

Report Period – 01/01/2021 – 12/31/2021

Type of Study	Update w/Site Visit
Date of Property Inspection	4/21/2020
Prepared By	Dale Gifford
Analysis Method	Cash Flow
Funding Goal	Full Funding

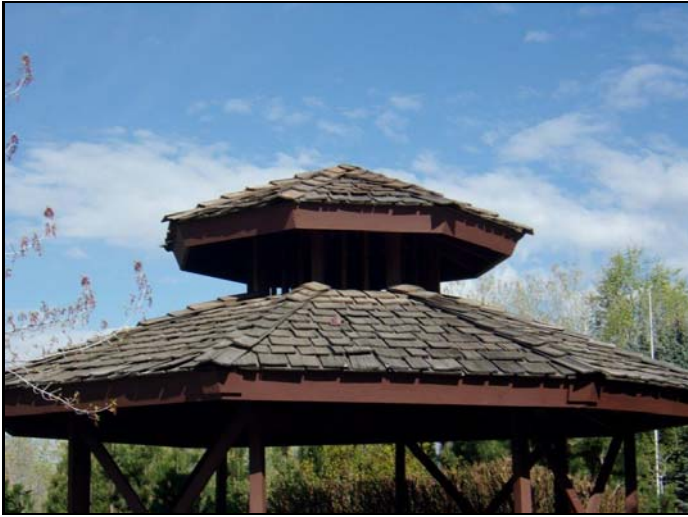
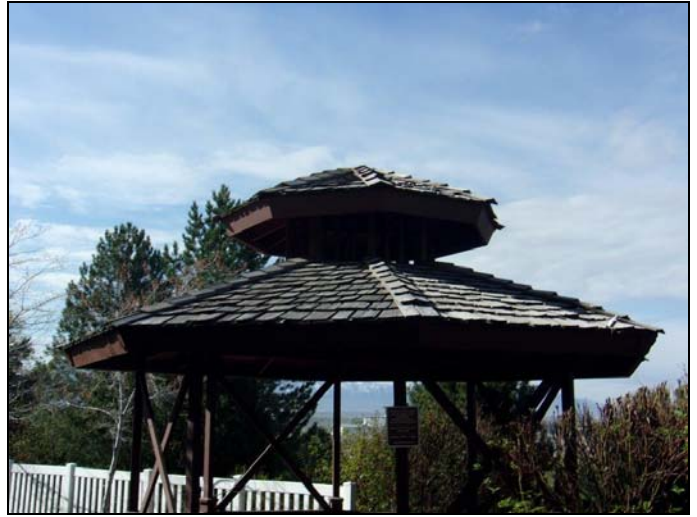
Comp #: 107 Shake Roof - Replace

Location: Gazebo Roof

The wood shake roof is in fair condition. We recommend funding to replace this component approximately every 25 - 35 years. Remaining life based on current age.

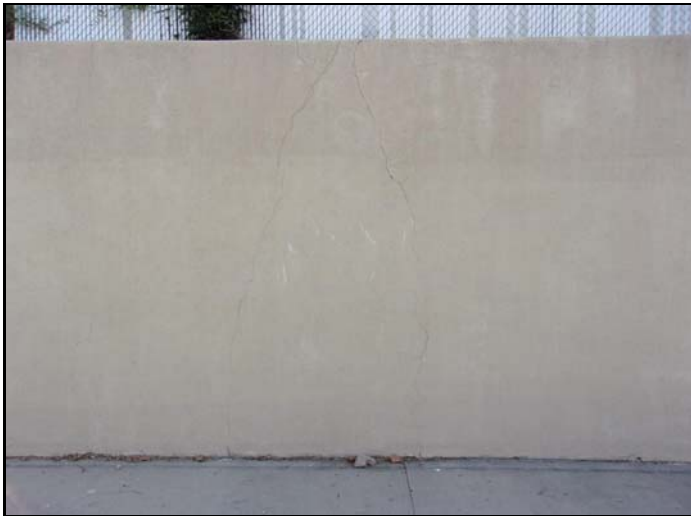
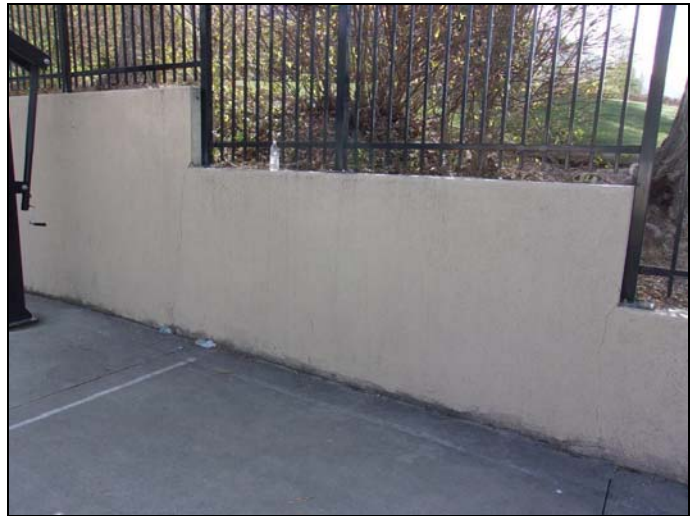
Comp #: 208 Stucco Wall - Courts Area - Repair/Repaint

Location: **Basketball & Volleyball Courts Area**

The stucco wall surfaces are in good to fair condition. We recommend funding to repair/repaint this component approximately every 8 - 10 years. Remaining life based on current age.

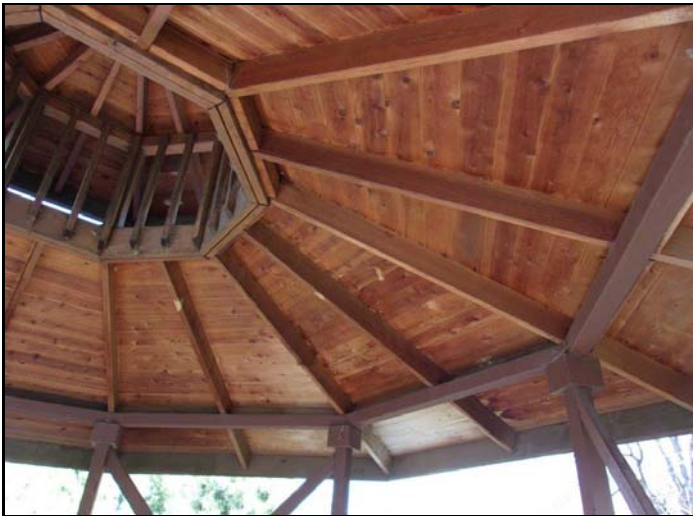
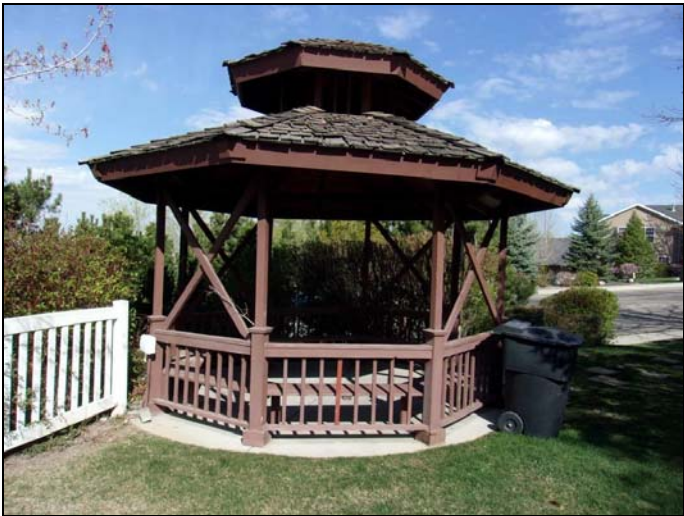
Comp #: 290 Gazebo - Repaint

Location: **Common Area**

Due to the minimal cost of repainting this component, reserve funding is not appropriate. Repaint as necessary as an operating expense. No reserve funding necessary.

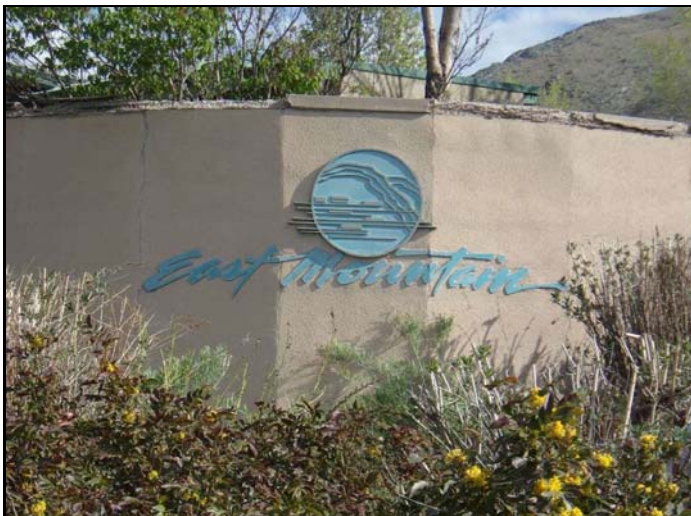
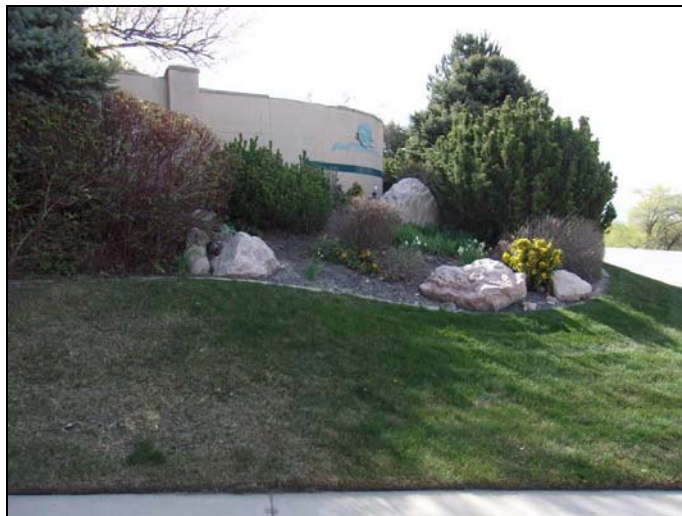
Comp #: 801 Monument Signs - Replace

Location: **Community Entrance**

Research with the client reveals this component will be replaced in 2021. We recommend funding to replace this component approximately every 20 - 25 years. Remaining life is based on current condition.

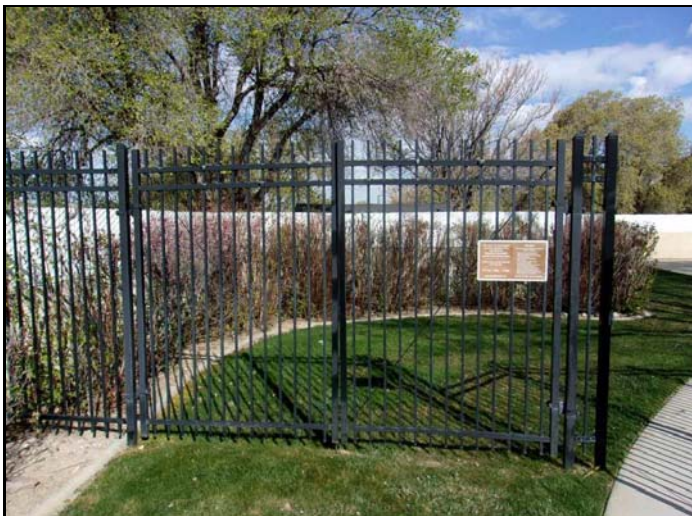
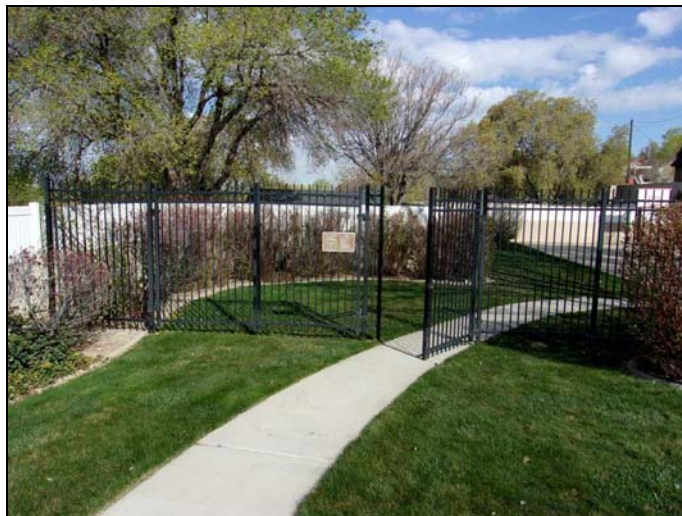
Comp #: 1002 Metal Fencing - Replace

Location: Common Area

The metal fencing is in good condition. We recommend funding to replace this component approximately every 40 - 50 years. Remaining life based on current age.

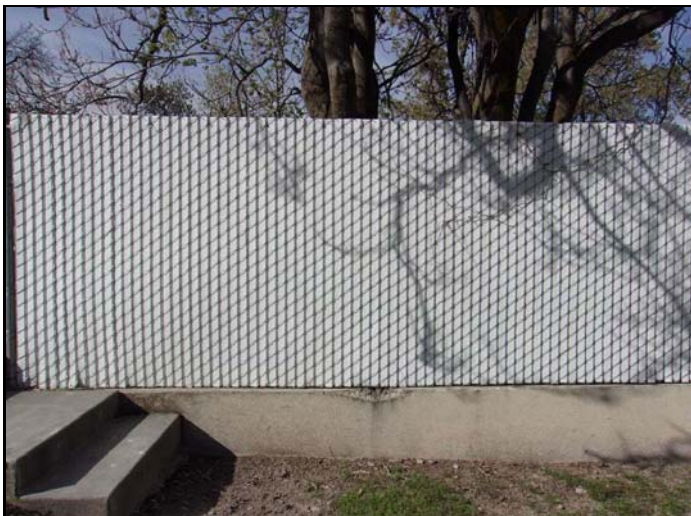
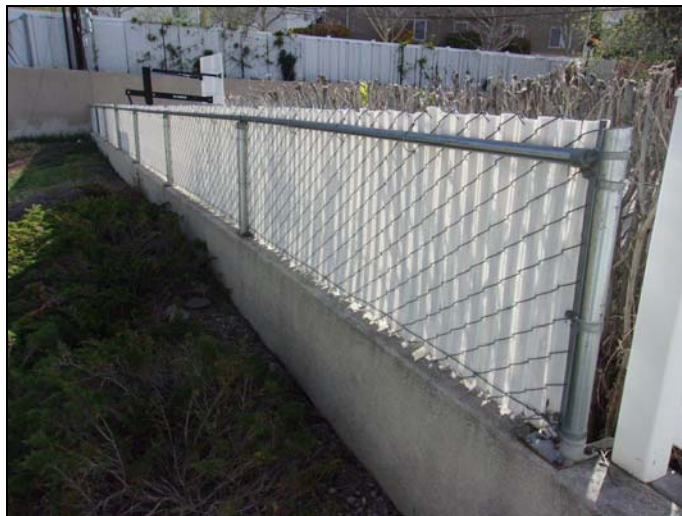
Comp #: 1003 Chain Link Fencing - Replace

Location: **Courts Area**

The chain link fencing is in fair condition. We recommend funding to replace this component approximately every 30 - 40 years. Remaining life based on current age.

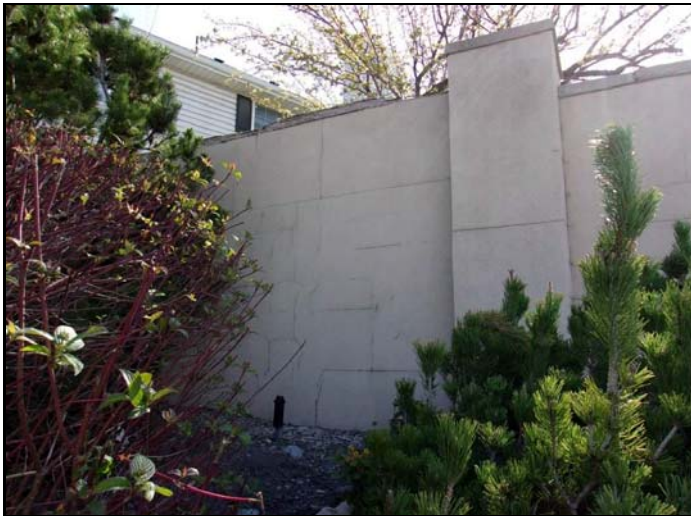
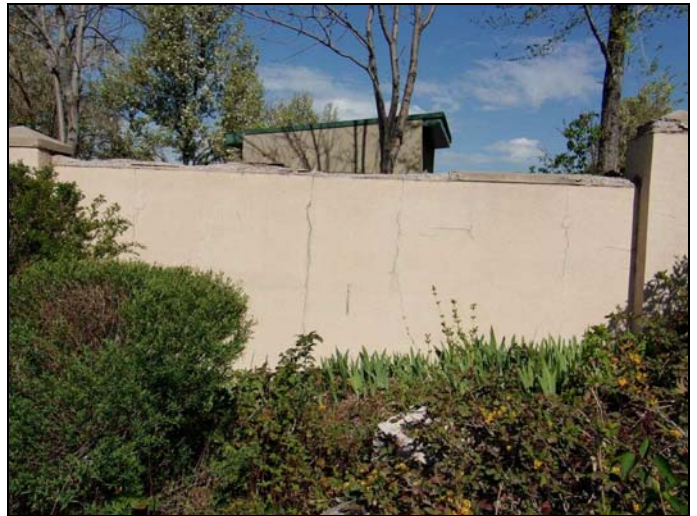
Comp #: 1005 Block Wall - Replace

Location: **Community Entrance**

Research with the client reveals this component will be replaced in 2023. We recommend the client look into replacing with a pre-fab concrete wall to lower maintenance cost in the future. This is a one time project.

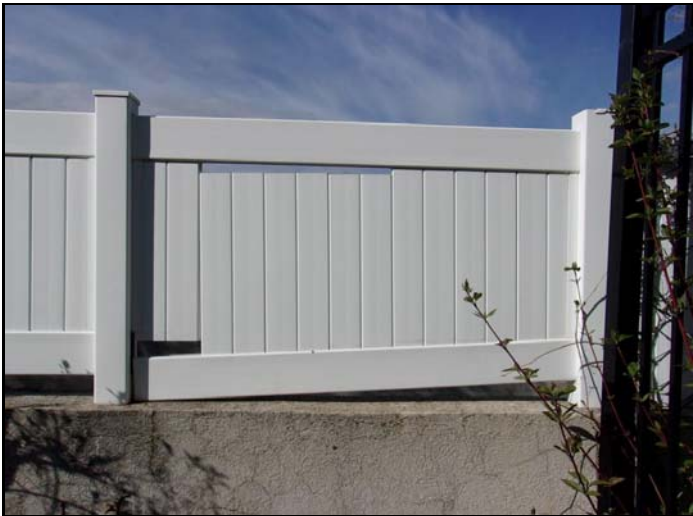
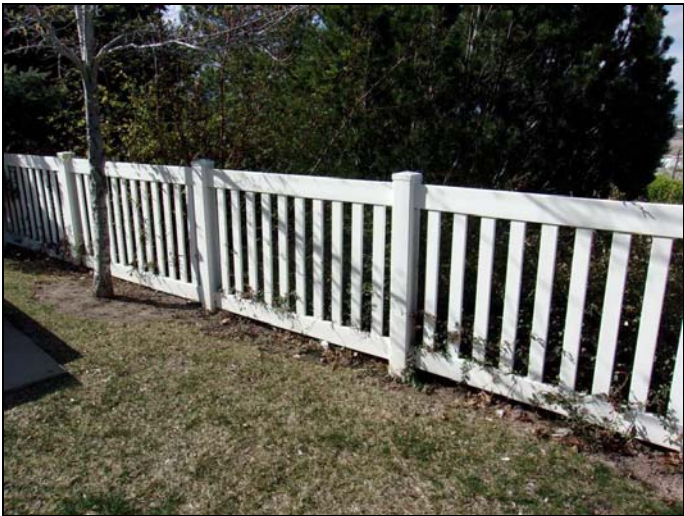
Comp #: 1008 Vinyl Fencing - Replace

Location: **Common Area**

The vinyl fencing is in good condition. We recommend funding to replace this component approximately every 25 - 30 years. Remaining life based on current age.

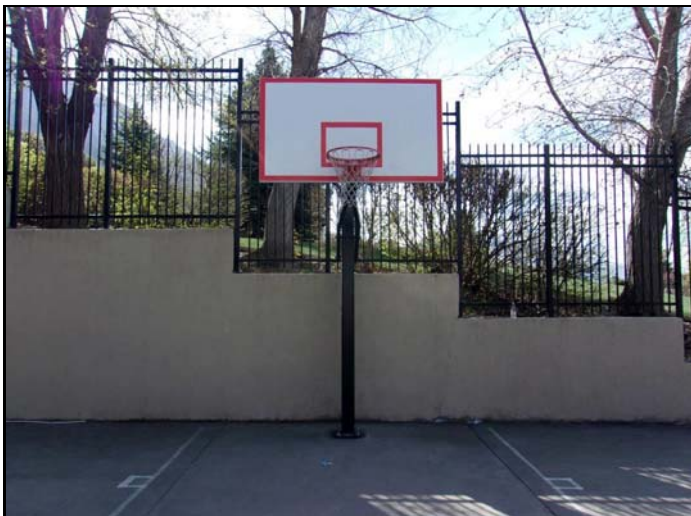
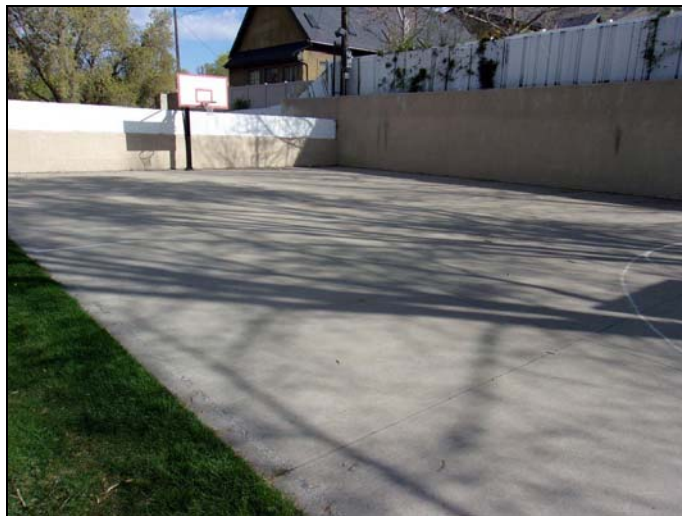
Comp #: 1206 Basketball Court - Replace

Location: **Common Area**

The basketball court is in fair condition. We recommend funding to replace this component approximately every 40 - 50 years. Remaining life based on current age.

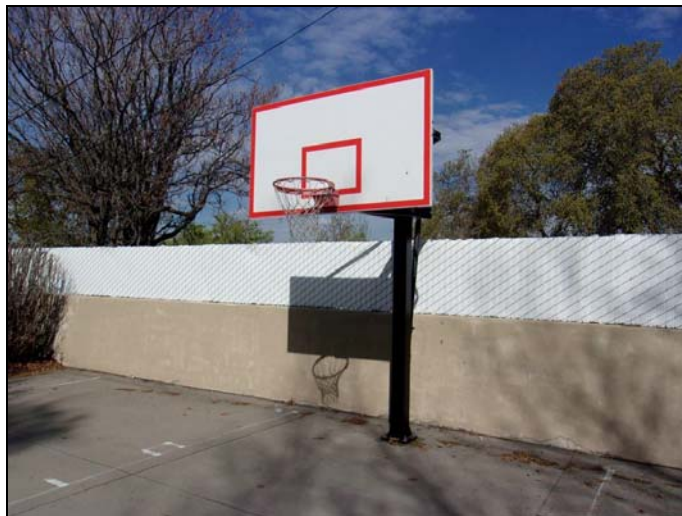
Comp #: 1207 Basketball Equipment - Replace

Location: Common Area

Research with the client reveals this component will be replaced in 2021. We recommend funding to replace this component approximately every 10 - 15 years. Remaining life is based on current age.

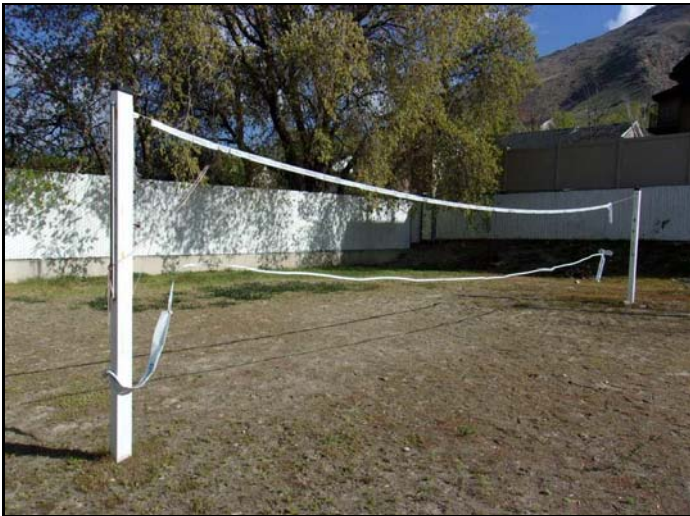
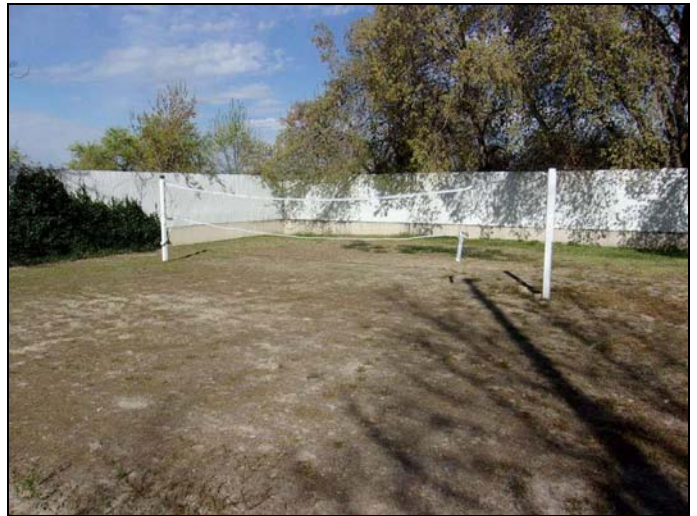
Comp #: 1208 Volleyball Court - Replenish

Location: **Common Area**

The volleyball court is in poor condition. We recommend funding an allowance to replenish this component approximately every 3 - 5 years. Remaining life based on current condition.

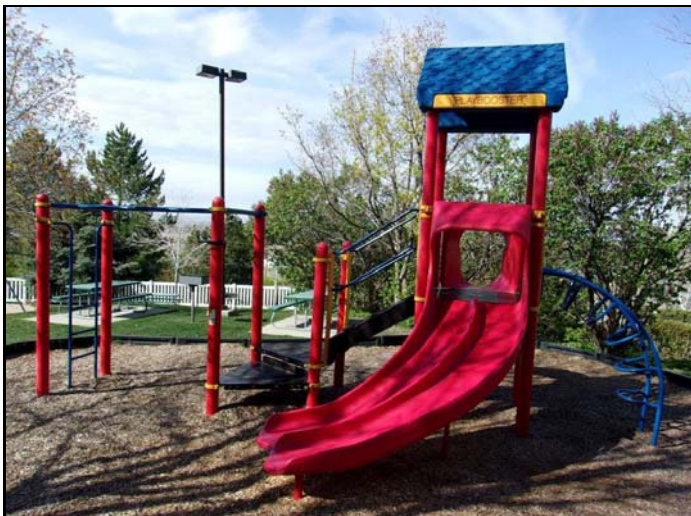
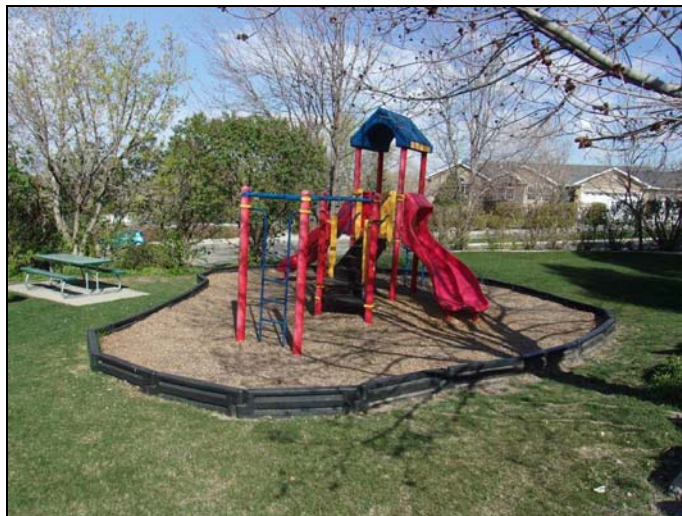
Comp #: 1301 Play Structure - Replace

Location: Common Area

The play structure is in good condition. We recommend funding to replace this component approximately every 20 - 25 years. Remaining life based on current age.

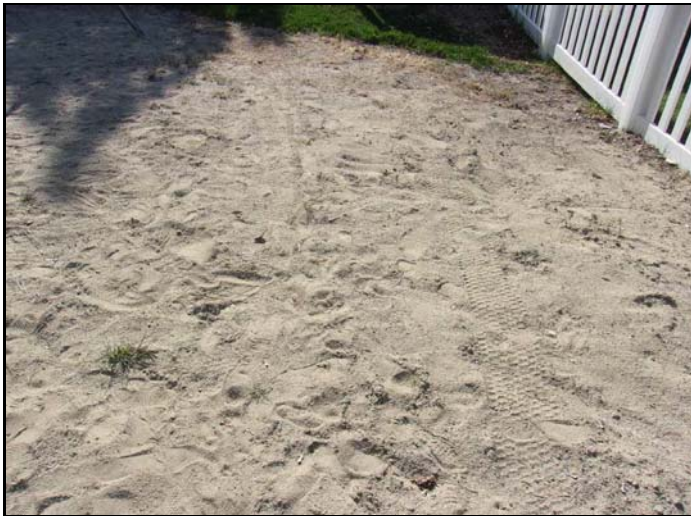
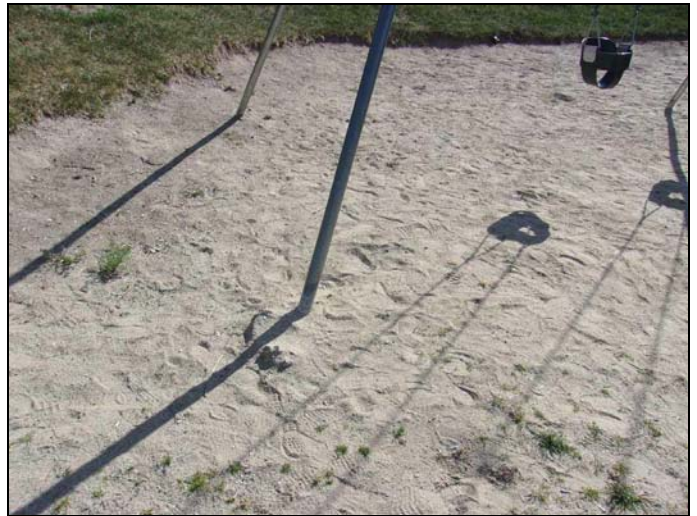
Comp #: 1303 Play Area Groundcover - Sand - Refill

Location: **Play Area**

The play area groundcover is in fair to poor condition. We recommend funding to refill this component approximately every 3 - 5 years. Remaining life is based on current age.

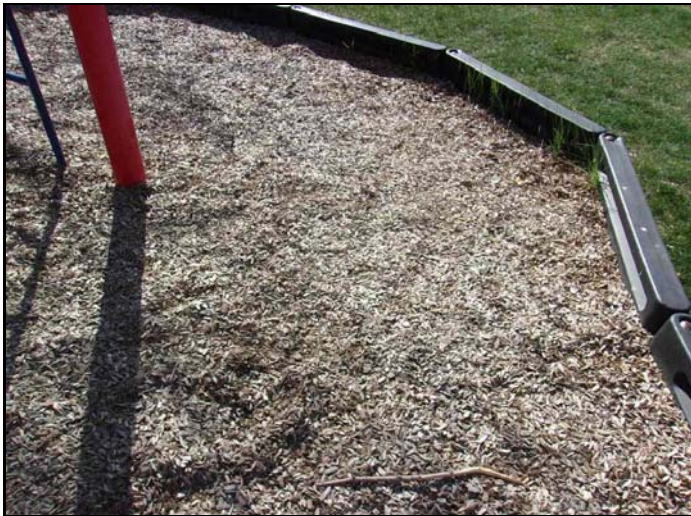
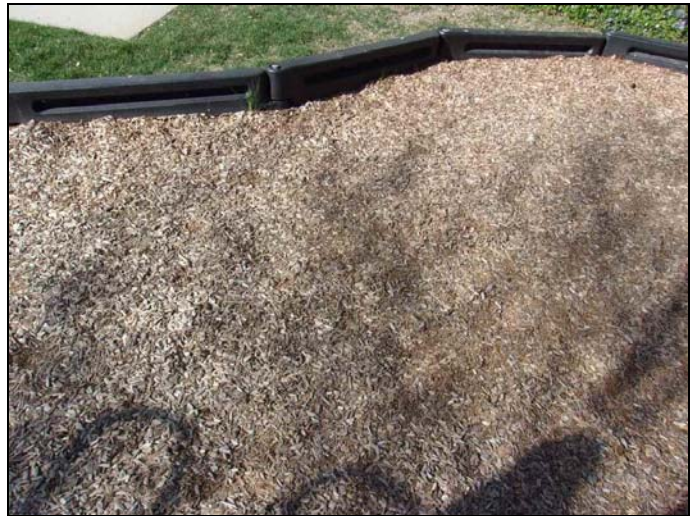
Comp #: 1303 Play Area Groundcover - Woodchip - Refill

Location: **Play Area**

The play area groundcover is in good condition. We recommend funding to refill this component approximately every 3 - 5 years. Remaining life is based on current age.

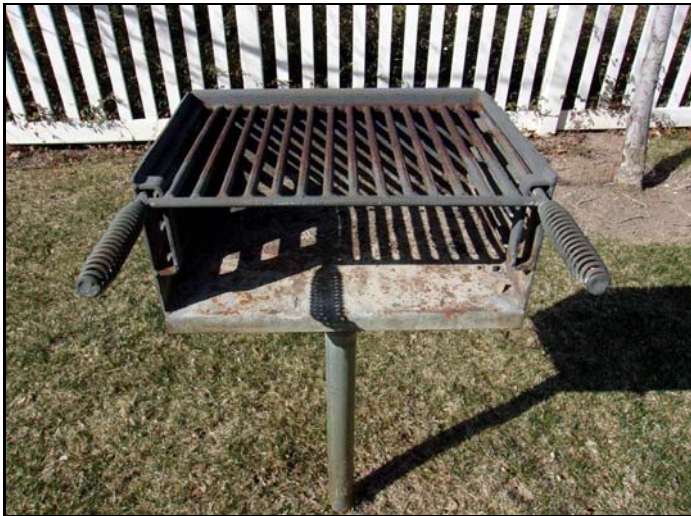
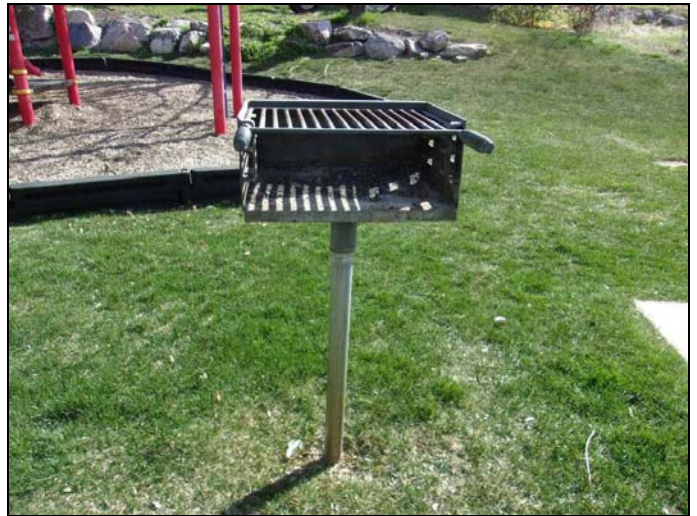
Comp #: 1305 Barbecue Grills - Replace

Location: **Common Area**

The barbecue grills are in fair condition. We recommend funding to replace this component approximately every 12 - 15 years. Remaining life based on current condition.

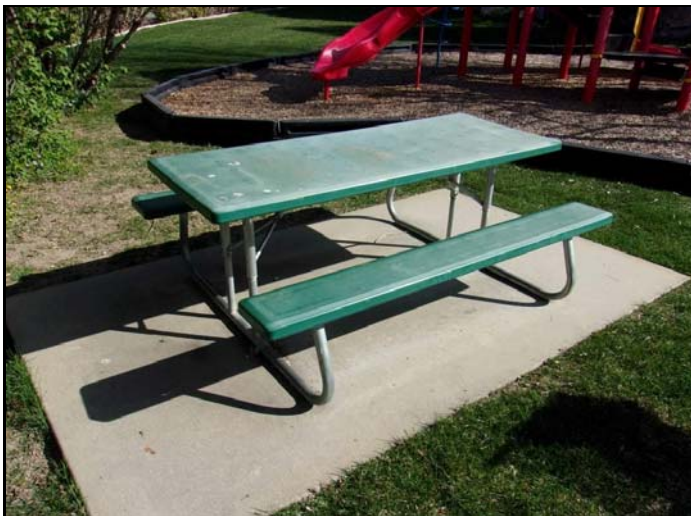
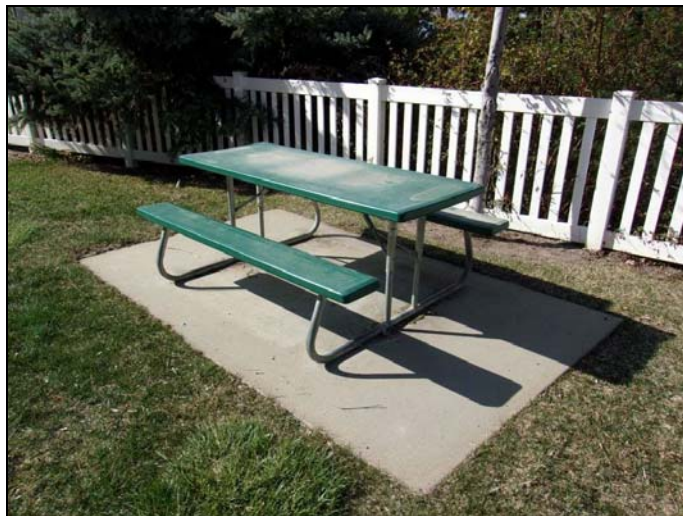
Comp #: 1306 Picnic Tables - Replace

Location: Common Area

The picnic tables are in fair condition. We recommend funding to replace this component approximately every 10 - 15 years. Remaining life based on current condition.

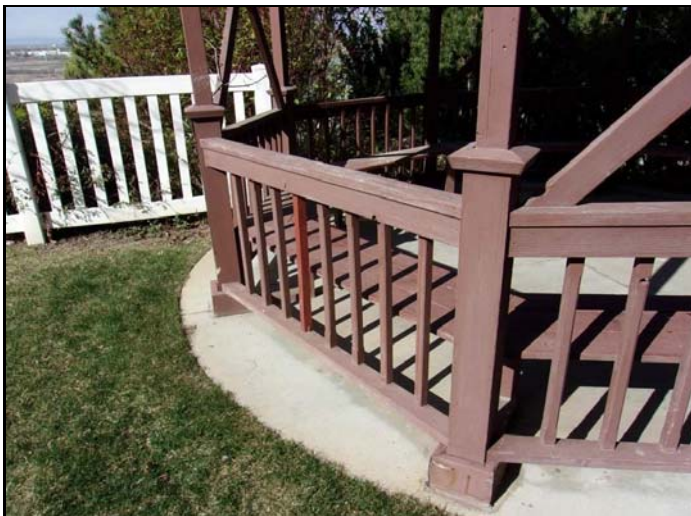
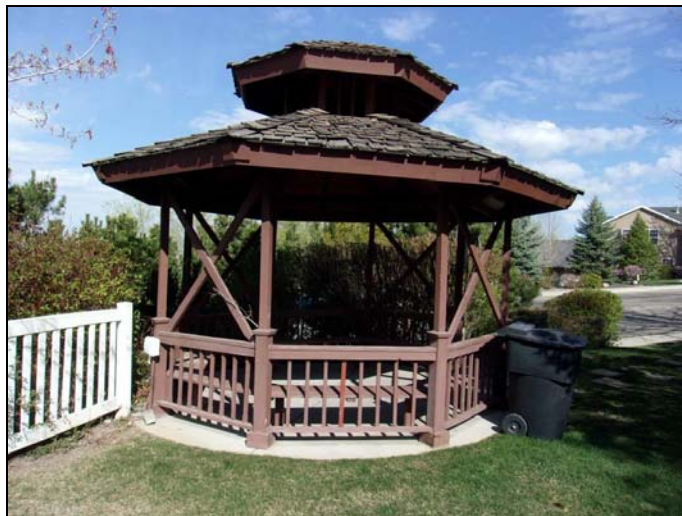
Comp #: 1309 Gazebo - Refurbish

Location: Common Area

The gazebo is in good to fair condition. We recommend funding to refurbish this component approximately every 10 - 15 years. Remaining life based on current age.

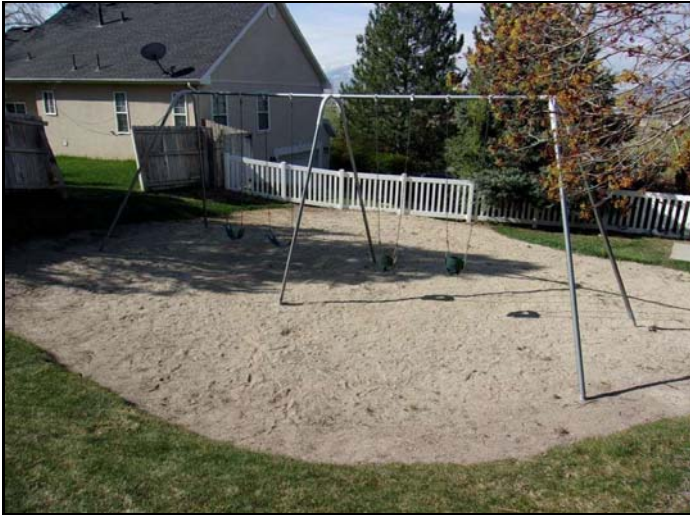
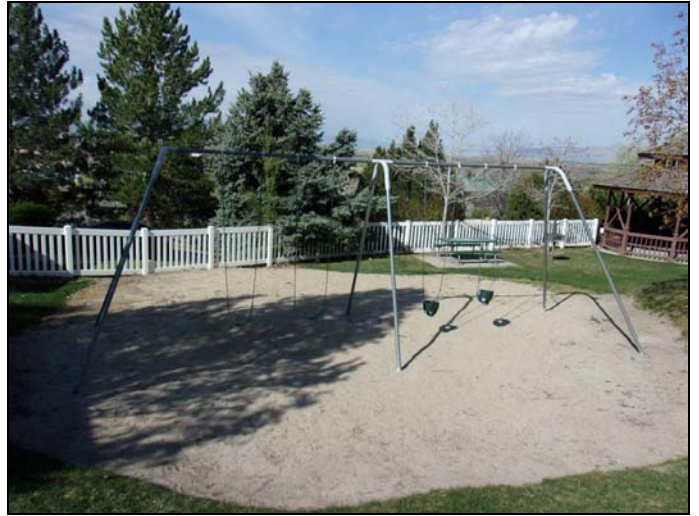
Comp #: 1390 Swing Set - Replace

Location: **Common Area**

The swing set is in good to fair condition. We recommend funding to replace this component approximately every 30 - 40 years. Remaining life based on current age.

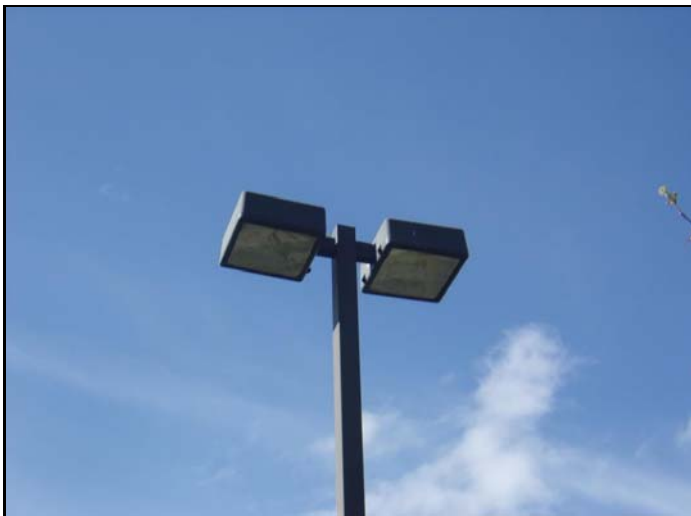
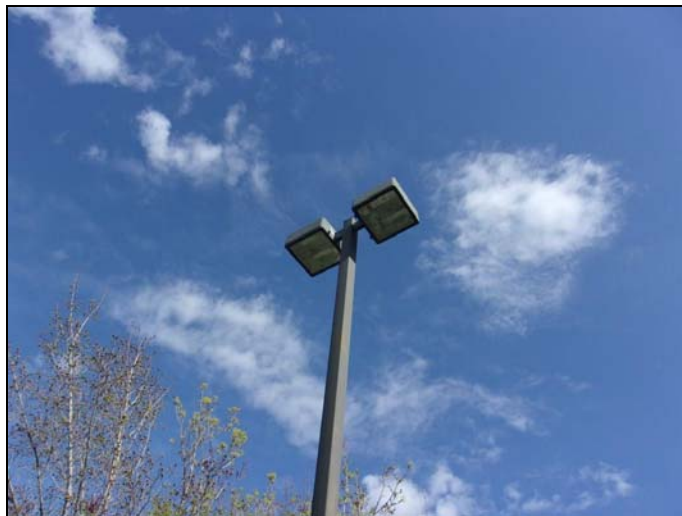
Comp #: 1609 Street Light Fixtures - Replace

Location: **Common Area**

The street light fixtures are in working condition. No expectation to replace the light poles. Paint poles as necessary as an operating expense. We recommend funding to replace this component approximately every 20 years. Remaining life based on current age.

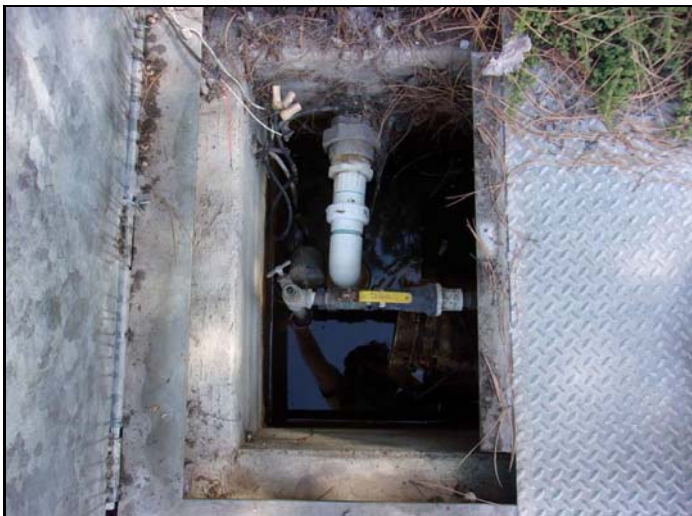
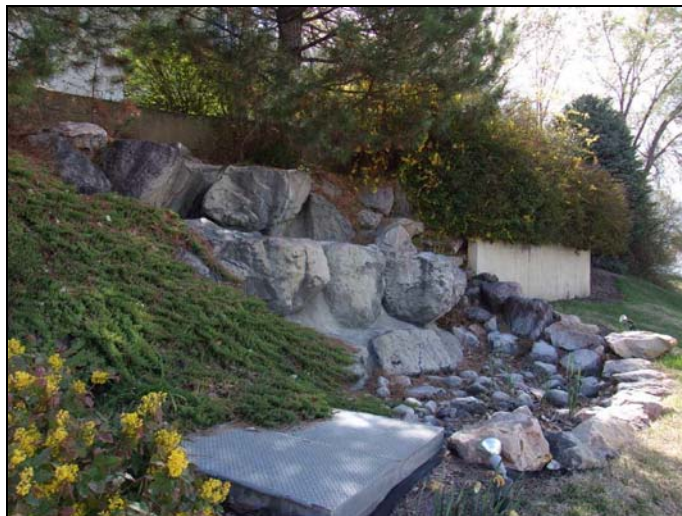
Comp #: 1809 Fountain - Replace

Location: **Common Area**

Due to the minimal cost of replacing this component, reserve funding is not appropriate. Make repairs as necessary as an operating expense. No reserve funding necessary.

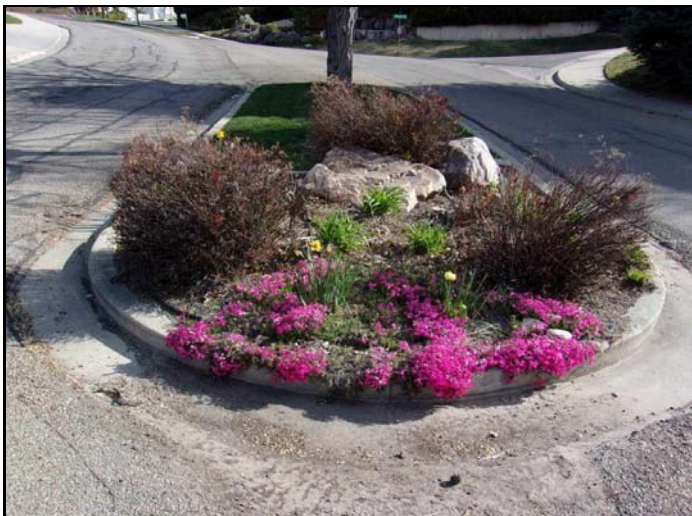
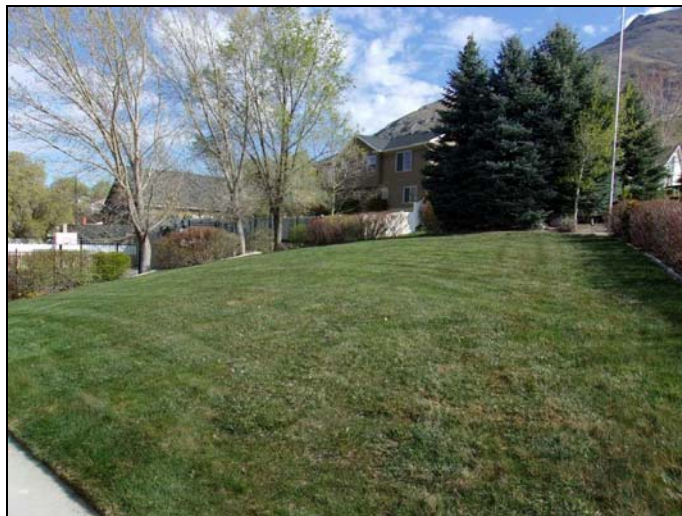
Comp #: 1812 Landscaping & Irrigation System - Renovate

Location: **Common Area**

The landscaping and irrigation system are in good condition. We recommend funding for an allowance to renovate the landscaping and irrigation system approximately every 20 years. Remaining life based on current age.
